# Analysis of the Line of Duty Death of Firefighter Nathan Flynn Utilizing Fire Dynamics Simulator, Fire Testing and Electronic Data Sources

7005 Woodscape Drive, Howard County, MD

Incident Date: July 23, 2018

**ATF BALTIMORE FIELD DIVISION**

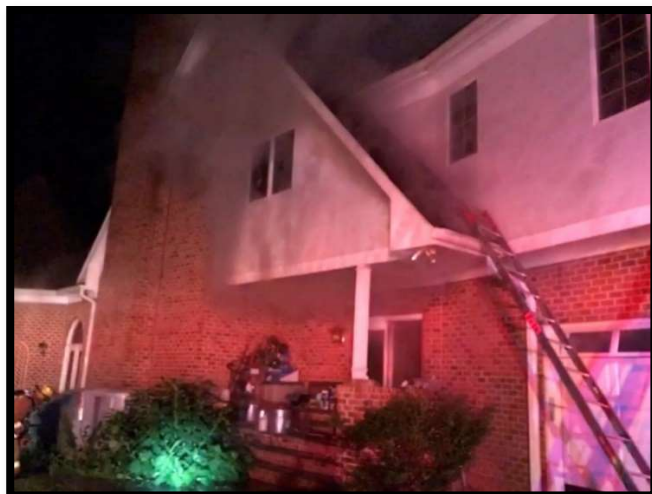
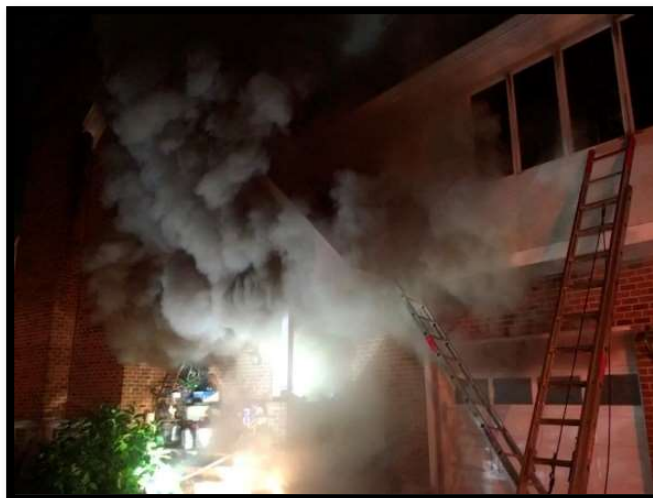
**Photo of exhaust flow path at the Upper Side C Entrance immediately before and immediately after the floor collapse and MAYDAY of FF Flynn.**

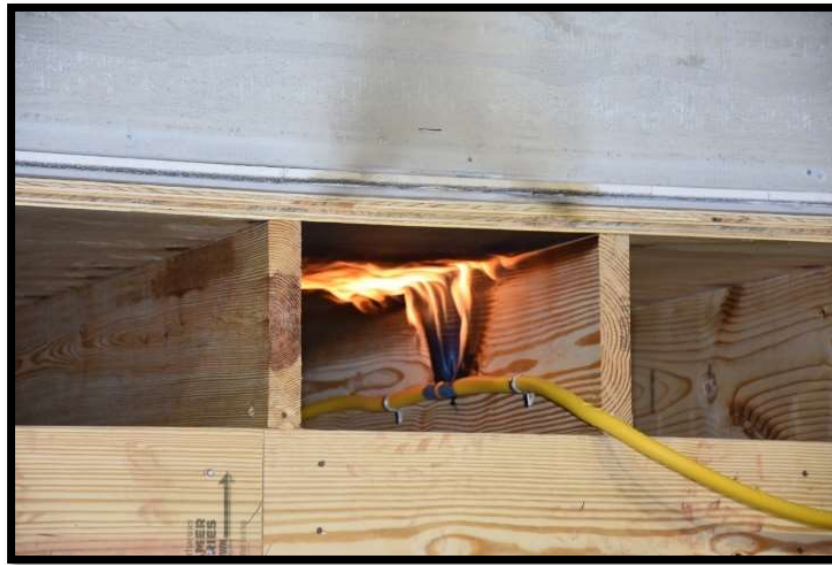
**ATF Fire Research Laboratory testing of a CSST gas line, ignition of the escaping gas and flame spread across the structural components of the flooring system from 7005 Woodscape Drive.**

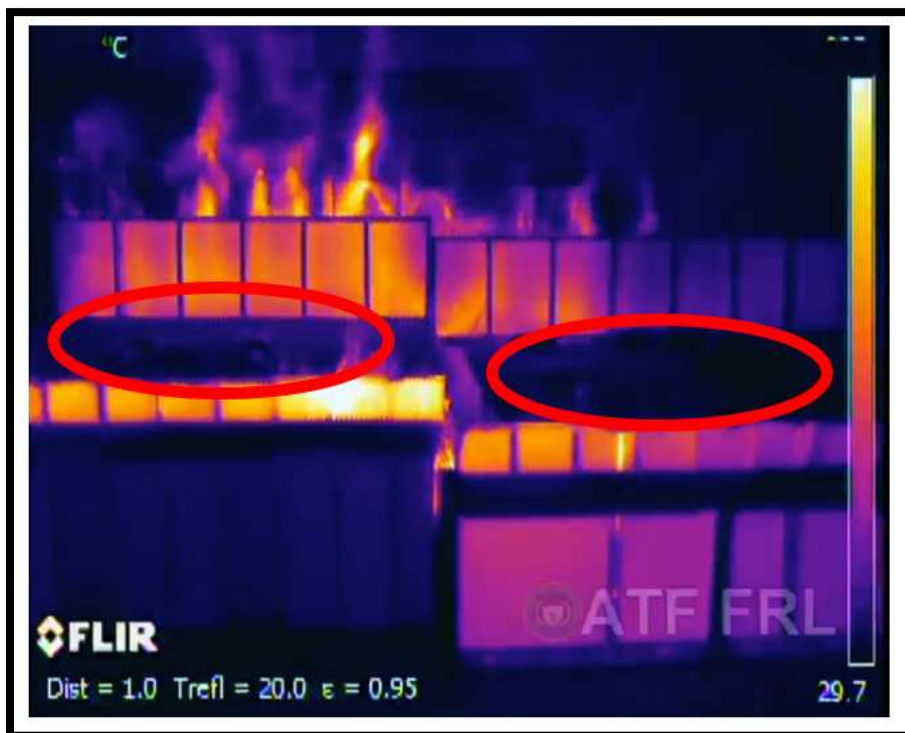
**Thermal imaging views of the floor system above the seat of the fire appeared “normal” and there were no obvious heat signatures consistent with a well-developed fire in the crawl space below.**

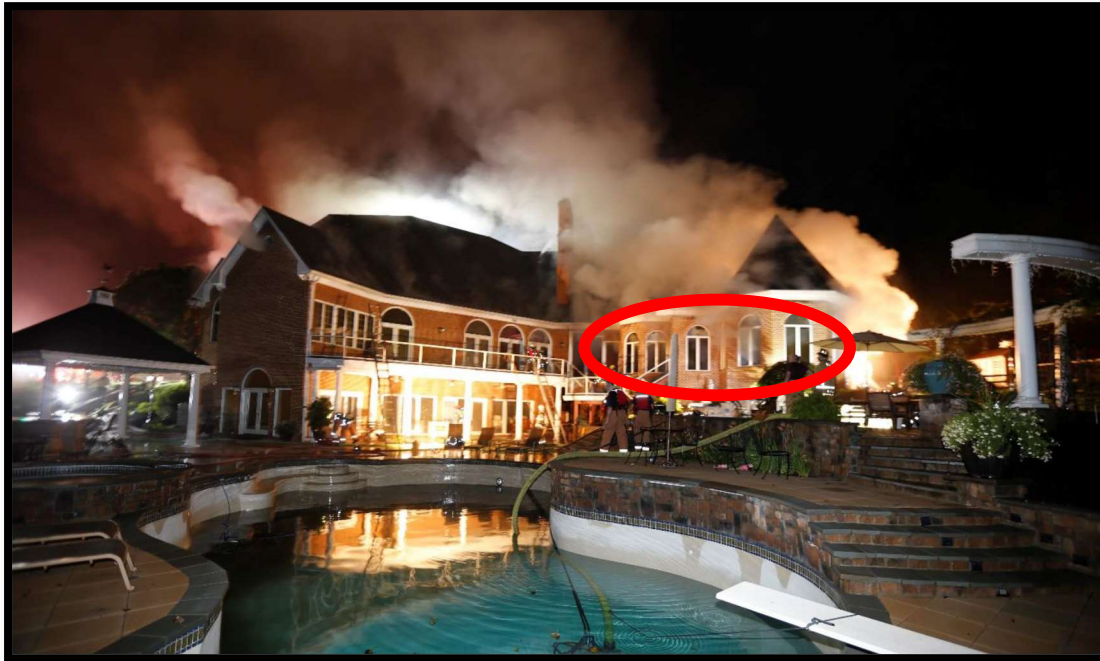
**Figure 5. An overall view of the rear (lower side C) of 7005 Woodscape Drive during the fire incident. The fire originated in the crawl space, located directly underneath the living room/kitchen (circled in the photo). There was no exterior access to the crawl space, which was located mostly below grade.**

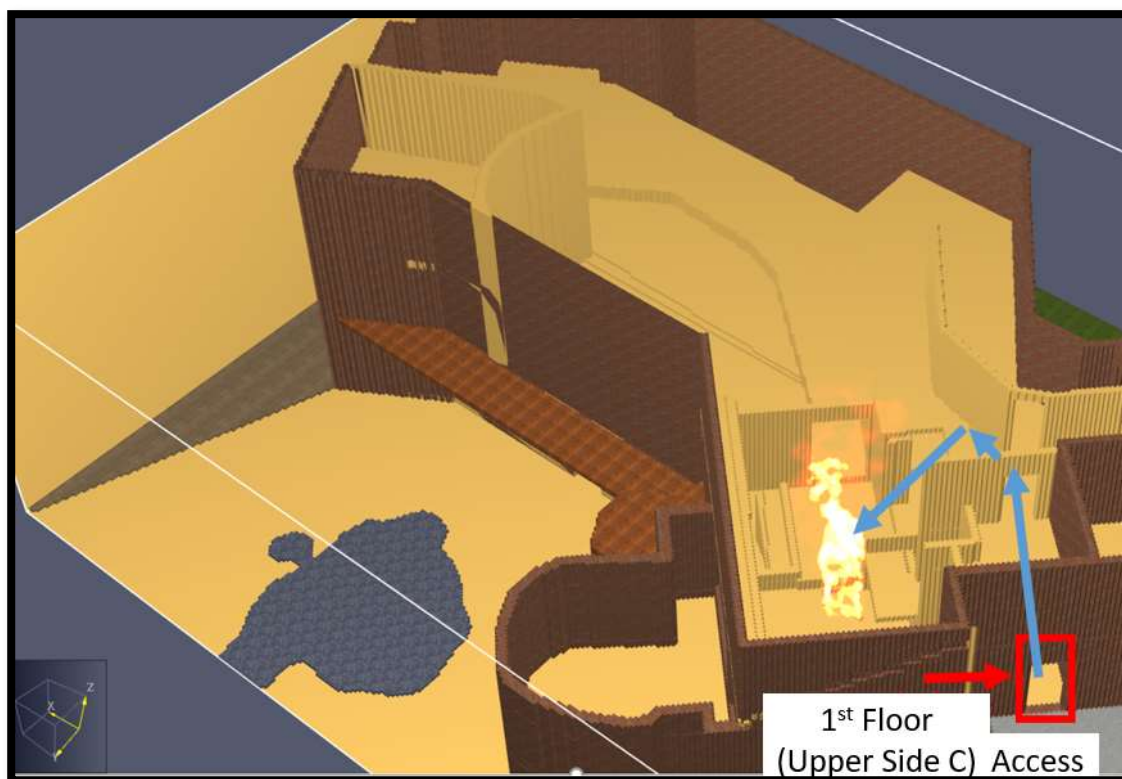
**Figure 11. Pyrosim Results image detailing flame extension through the hole from the crawl space to the first floor at the approximate time of FF Flynn’s MAYDAY. The modeled smoke has been disabled in this image. Blue arrows indicated general path of the hoseline advanced by Firefighter Flynn just prior to the MAYDAY.**

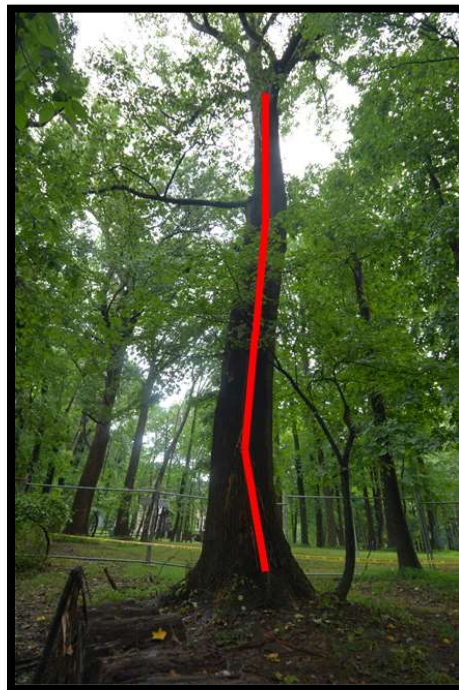
**Figure 14. Photograph depicting splitting to the trunk of a large tree located proximal to 7005 Woodscape Drive. The red lines depict the lightning induced damage. The soil between this tree and an underground propane storage tank was also displaced, forming a shallow trough in the earth.**

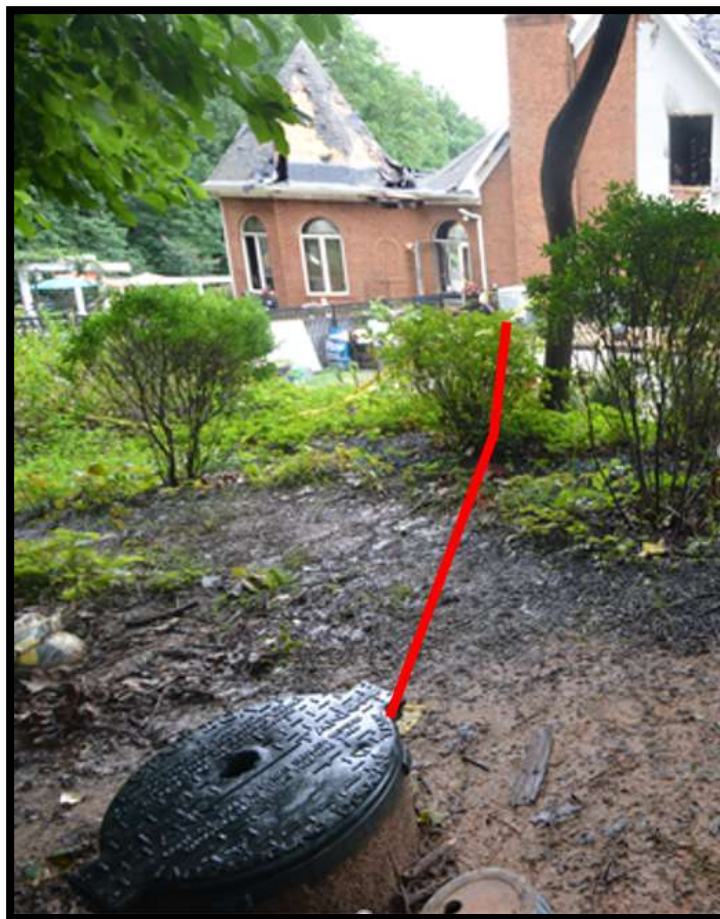
**Figure 15. Access cover to the underground propane storage tank proximal to the large tree with lightning damage. Copper Propane supply piping ran underground from this tank to where it entered the crawl space through the exterior upper side C wall, roughly following the red line in the photo. The propane supply piping then transitioned to corrugated stainless steel tubing (CSST) after entering the crawl space. A small hole caused by arcing was located in the CSST. No evidence of CSST bonding (grounding) was observed, including the service entrance and CSST supply manifold.**

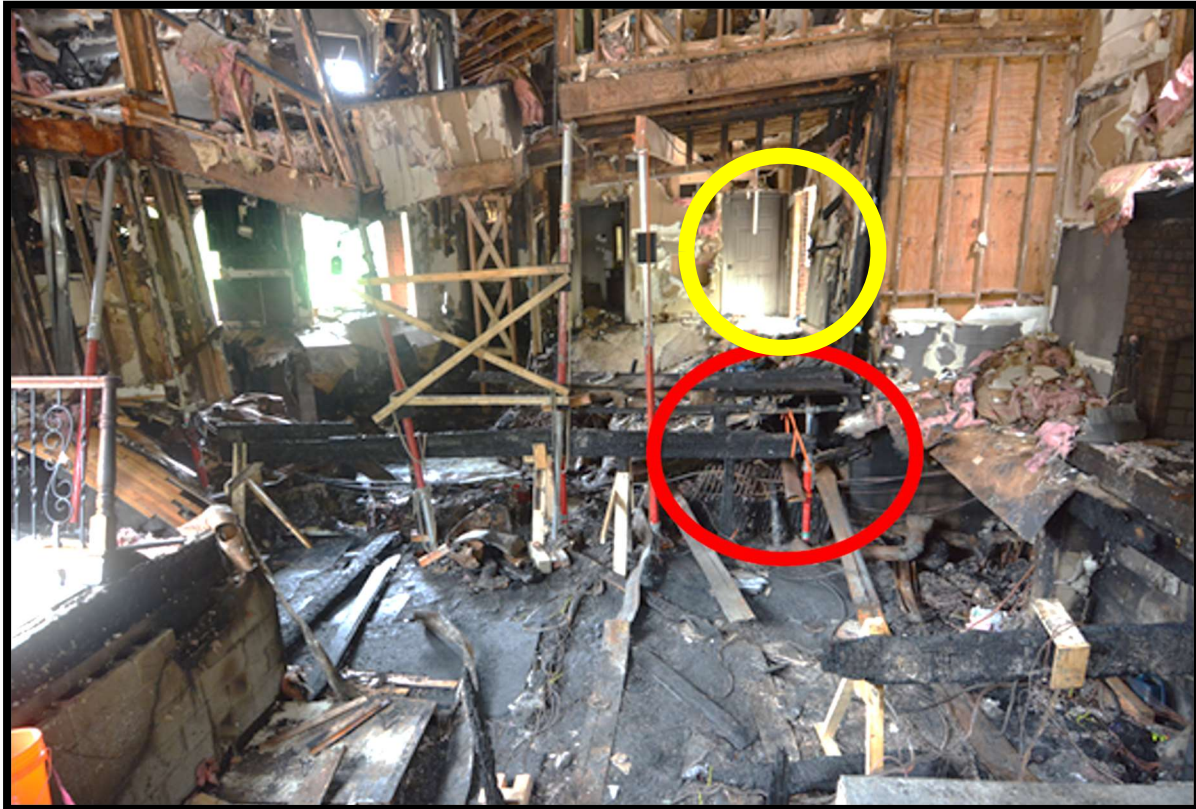
**Figure 19. Interior photo (post-fire) depicting the living room and crawl space below. The red ellipse indicates the approximate location of the arc hole discovered in the CSST that resulted in sustained ignition of a propane flame approximately 6 inches (15.2 centimeters) in height. The flames eventually spread to wooden structural members and combustible items stored in the crawl space. The yellow ellipse indicates the exterior mud room door that Firefighter Flynn advanced the hoseline through prior to falling into the burning crawl space below.**

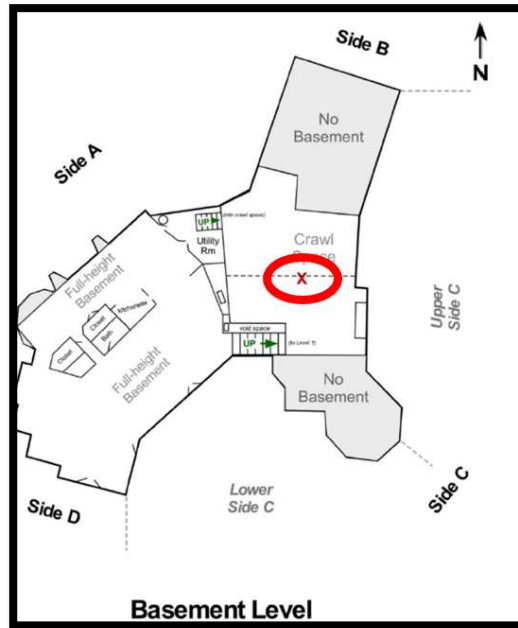
**Figure 20. Diagram of the basement level with red ellipse indicating general location of arc damaged CSST. The living room was located directly above this ellipse. The location of the hole that Firefighter Flynn fell into the basement was located just to the left of the red circle.**

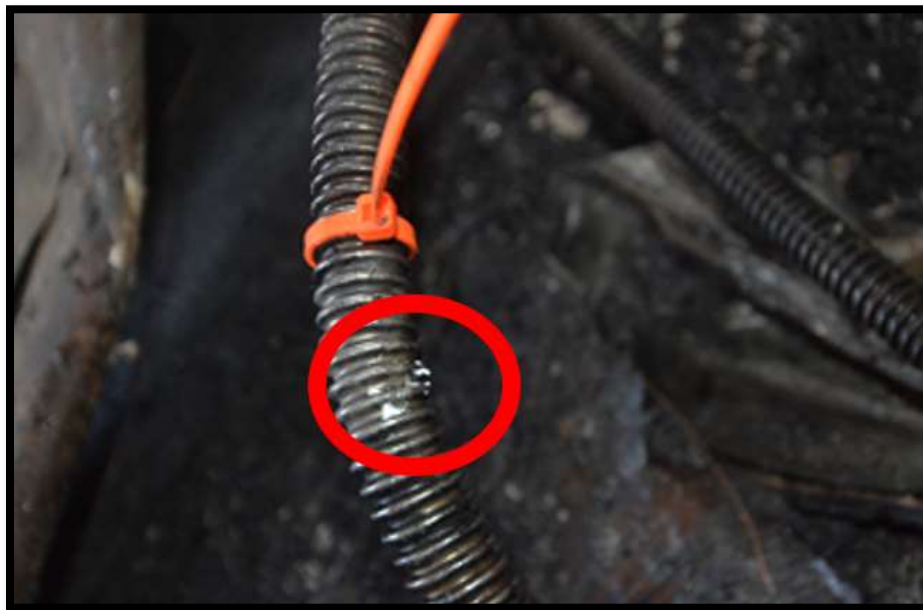
In this case, the nearby (indirect) lightning strike energized the propane distribution system, and caused the CSST routed below the living room to arc to a nearby grounded object in the crawl space. A metal HVAC duct and a metal dryer vent were located in the immediate vicinity of the CSST arc site, however no corresponding arc site damage to these items was identified by investigators. As the lightning induced electrical energy travels through the thin stainless-steel wall of the CSST, it may contact an adjacent metal object (at a different electrical potential). The result is a high-temperature electrical discharge, or arc, which can create a hole (or multiple holes) in the CSST wall. The energy from this discharge can not only cause a leak of gas, but can also ignite the escaping gas simultaneously. In this case, this event created a small, sustained propane diffusion flame along the ceiling of the crawl space proximal to the wood floor joists and other combustible items stored in that area, including stacked Christmas decorations below. Field fire testing was conducted that estimated this flame to be about 6 inches (15.2 centimeters) in height. At this particular incident, smoke was first noted by occupants approximately 20 minutes after the lightning strike, and Firefighter Flynn’s MAYDAY call occurred 60 minutes following the strike.

**Figure 21. Scene photo depicting small hole created in the propane CSST supply line. The propane supply tank and associated piping became energized by the nearby lightning strike, causing the CSST to arc to a nearby grounded object. The arcing event melted the thin stainless steel wall of the CSST, which formed a hole and likely ignited the escaping propane. A sustained propane diffusion flame occurred at the location of the hole.**

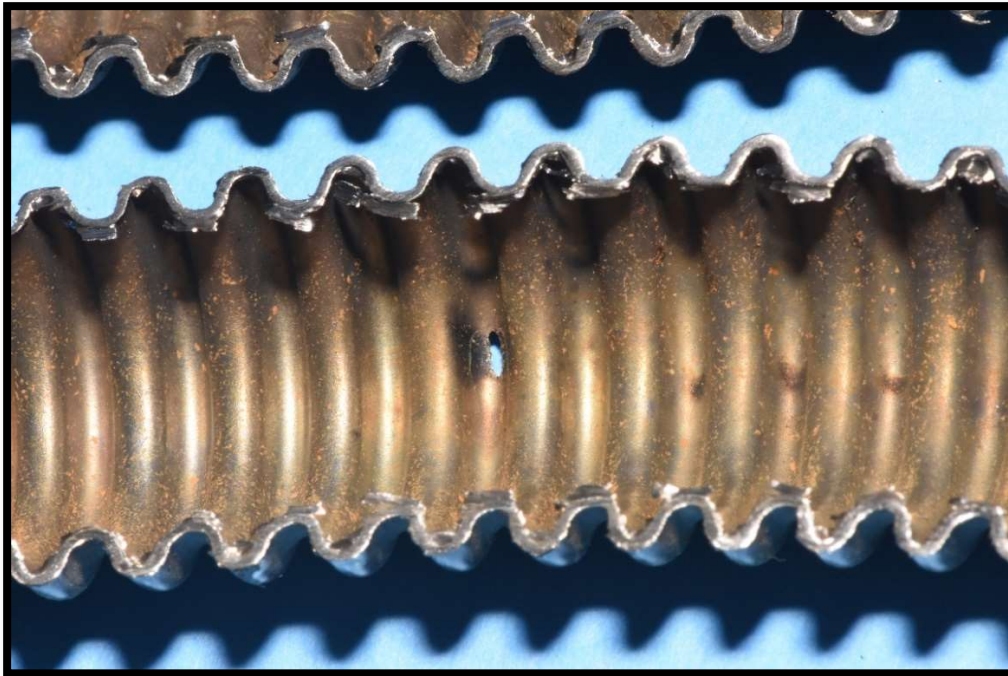
**Figure 22. Forensic cutaway depicting the inside of the CSST and the arcing damage caused by the lightning strike.**

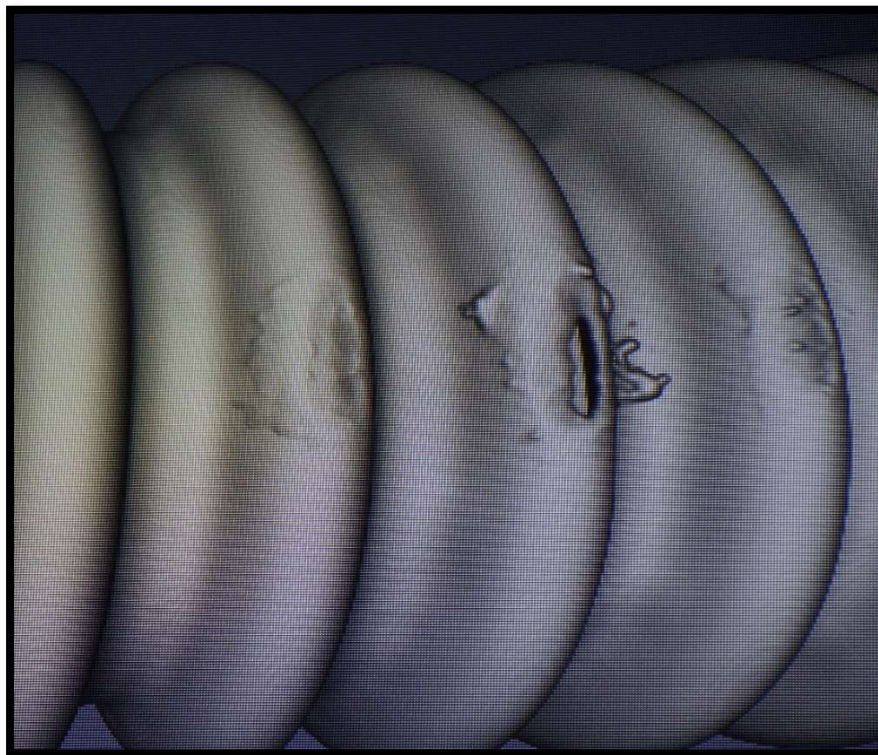
**Figure 23. A computerized tomography (CT) scan of the CSST arc damage.**

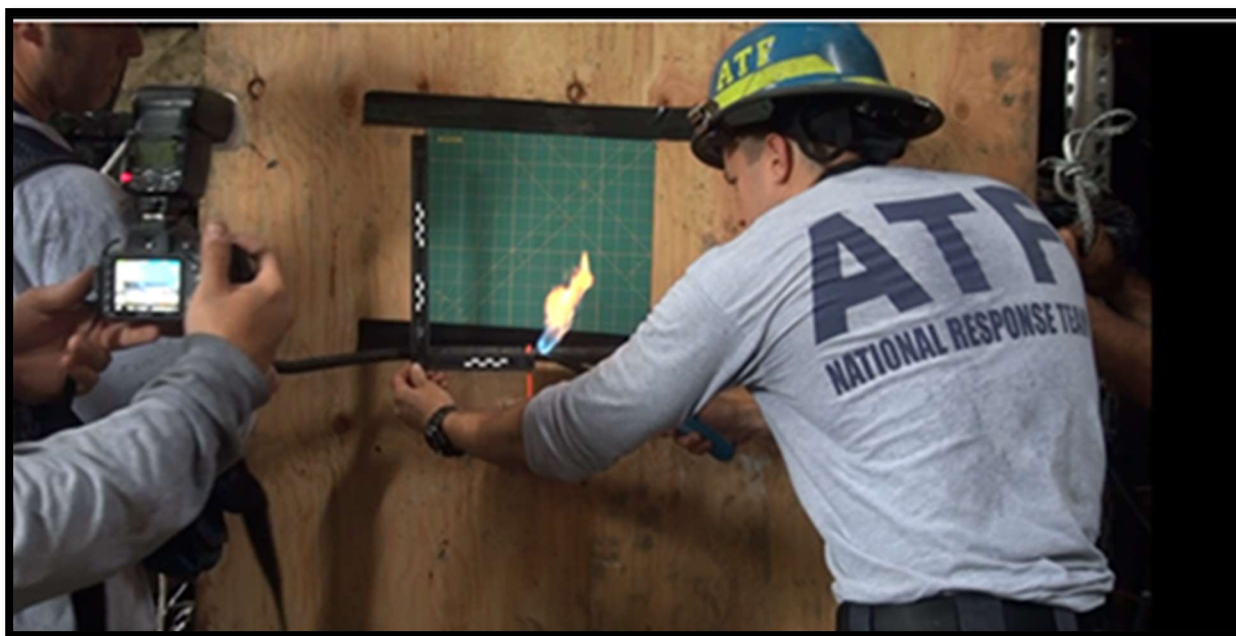
**Figure 24. Field fire testing was conducted by ATF at the scene to document flame height using the original propane system. The results of the field fire testing were then used to design subsequent large-scale fire tests at the ATF Fire Research Laboratory.**

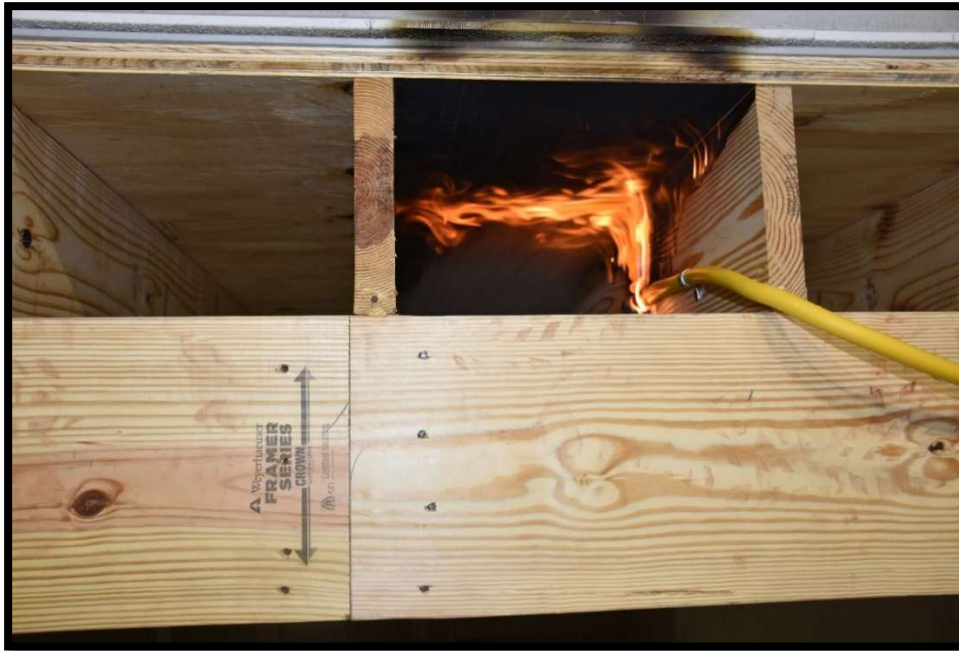
**Figure 30. Despite having significant exposed combustible wood structural material in the crawl space, fire spread beyond the propane leak was slow and remained limited until combustible storage material was ignited below the wooden flooring system.**

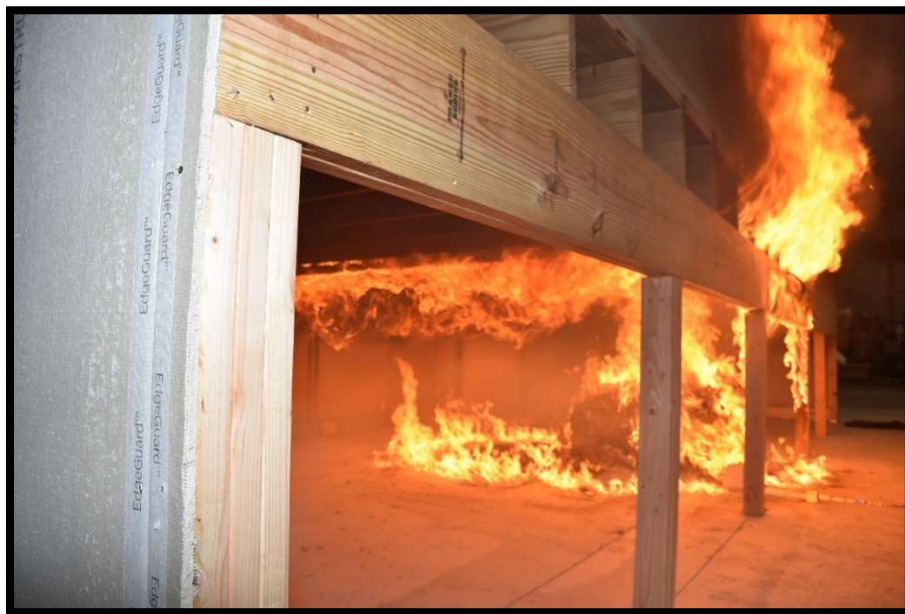
**Figure 31. Once combustible materials were ignited below the flooring system, flames rapidly extended throughout the crawl space in just under 10 minutes. This observation is consistent with the relatively slow production of smoke initially observed by occupants and firefighters followed by rapidly increasing smoke and heat production within the residence.**

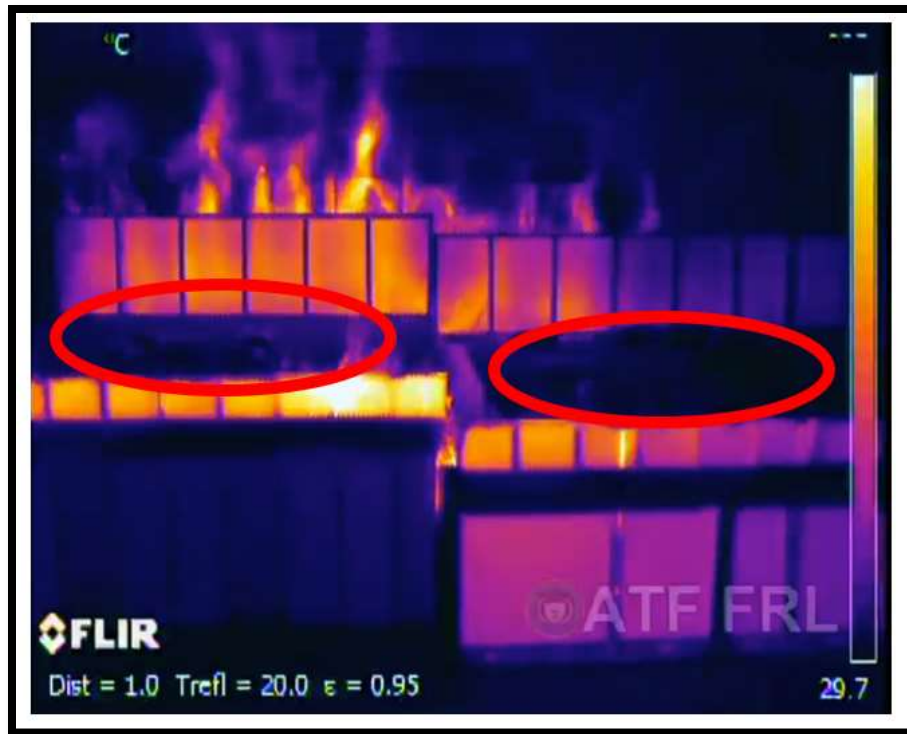
While the floor joists and OSB sheathing supported flame spread and burned-away, the non-combustible tile and tile backing appeared relatively cool on infrared thermal imaging cameras and remained intact despite having compromised structural support below (Figure 32). The relatively massive construction of the flooring system (thermally thick) masked the heat signatures one might expect from a fully-involved crawl space fire and a structurally-compromised flooring system below.

**Figure 32. Despite having a fully-involved crawl space and compromised structural integrity, the top of the flooring tiles appeared relatively cool on thermal imaging IR cameras (areas circled in red). This same thermal imaging technology was used by firefighters operating on the first floor (above the crawl space).**

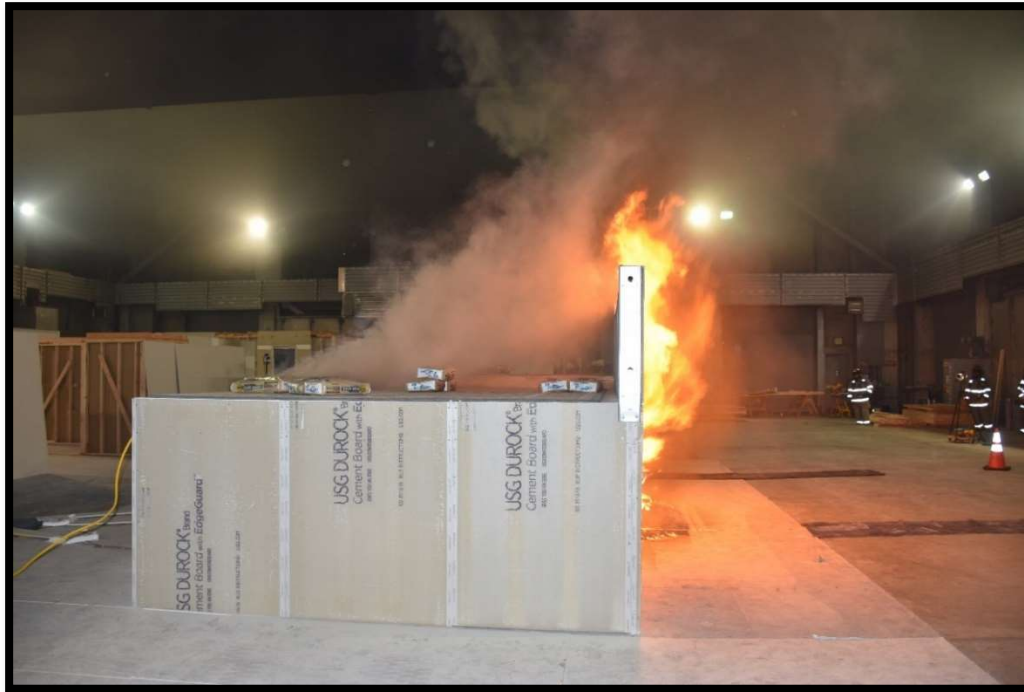
**Figure 33. Smoke production through the tile floor with a well-developed fire in the crawl space underneath. The thermally thick (massive) living room floor construction helped mask the well-developed fire underneath firefighting crews operating above.**

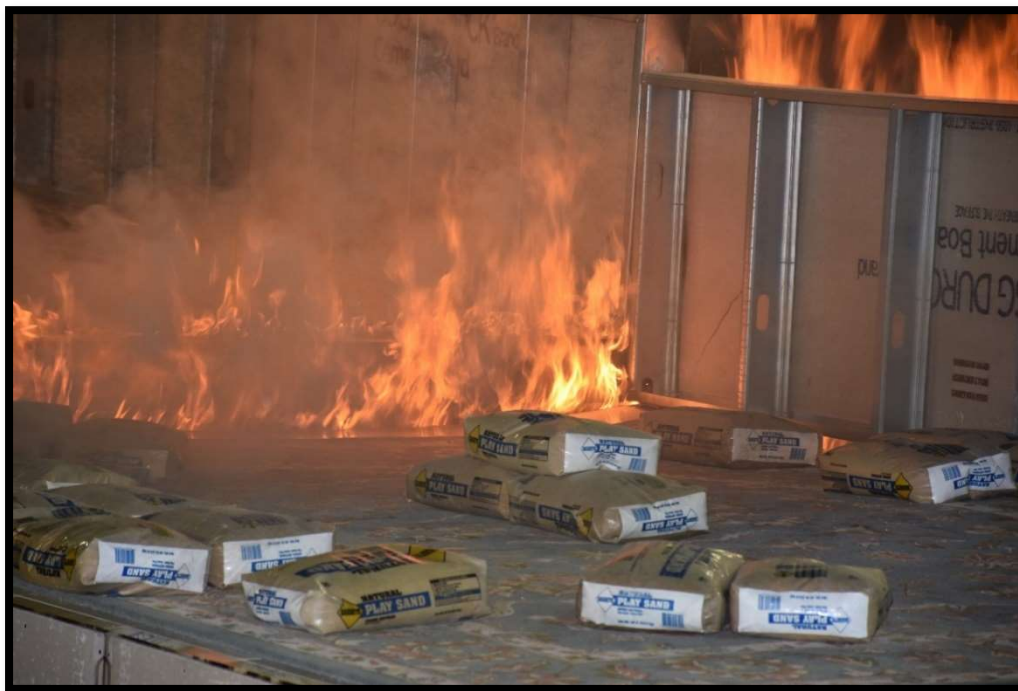
Flame extension from the crawl space to the first floor was observed where flooring material was joined together, likely accounting for flame spread from the crawl space to combustible furniture items in the first floor living room as witnessed by firefighters on the exterior. This flame extension was witnessed by firefighters who now believed the seat of the fire was located on the first level, not the basement. This observation resulted in the redeployment of the basement handlines back to the first floor. Firefighter Flynn fell into the crawl space hole a short period after entering the first floor with the hoseline.

**Figure 34. Flame extension from the crawl space to the first floor was observed where flooring material was joined together, likely accounting for flame spread from the crawl space to combustible furniture items on the first floor living room as witnessed by firefighters. This flame extension was witnessed by firefighters who now believed the seat of the fire was located on the first level, not the basement. This flame extension caused firefighters to reposition a hoseline from the basement back to the first floor.**

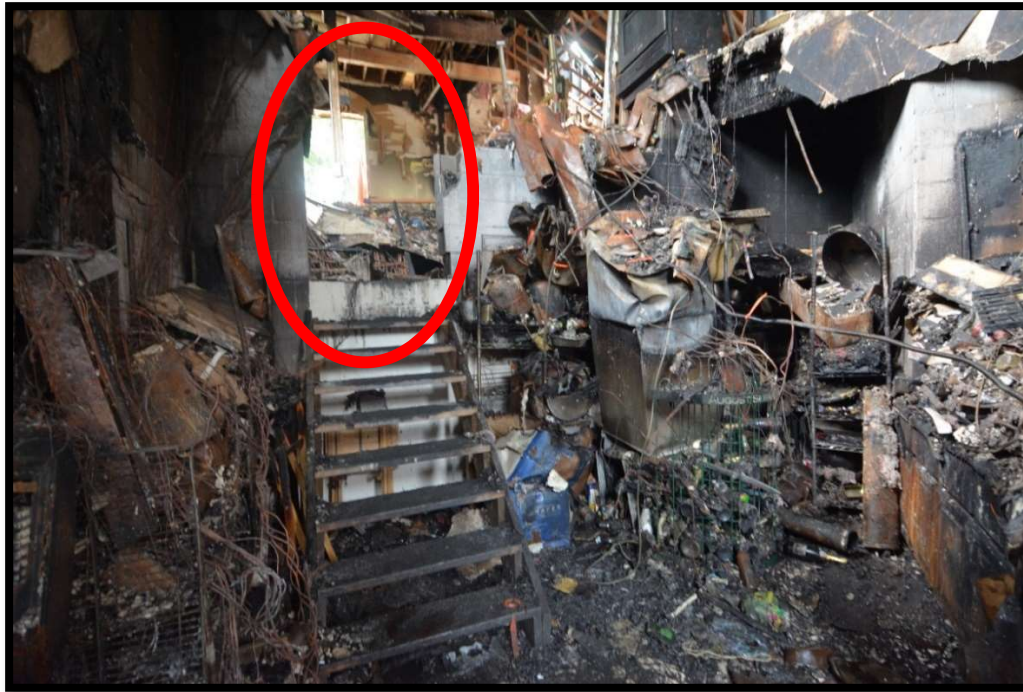
**Figure 47. Post-fire photograph indicating the ½ flight of stairs leading from the basement to the entrance to the crawl space. Note that the crawl space floor is elevated approximately 5 feet (1.5 meters) above the basement floor. RIT crews immediately encountered flames upon entering the crawl space. Firefighter Flynn was removed by the RIT through this opening.**
